Article

# Method for evaluating the snagging propensity of roofing membranes in buildings by roosting bats

## Abstract

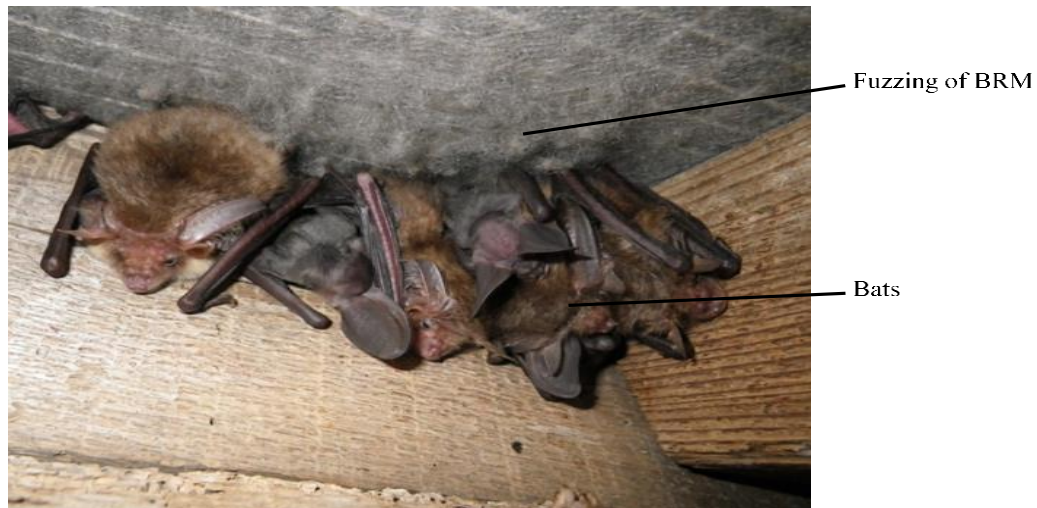
**Figure 4.** Example of fuzzing on a nonwoven membrane within a bat colony (Courtesy of John Martin, Cumbria, UK)

During roosting, bats physically interact with the surface of roofing membranes through the gaps between battens and in the roof space (Figure 4). Their claws snag the surface of the NBCRM, which can cause loops of continuous filaments to be teased free from the fabric structure to produce surface 'fluffiness'. Concerns have been raised since 2004 about the level of bat mortality (Waring et al, 2013; Waring, 2014) as they are often caught in these loose, strong filaments, becoming fatally entangled. In Scotland this situation would not normally arise in the roof void as the membrane would be located behind the wooden sarking boards, against which the bats would roost. However, there is still potential for crevice dwelling bats such as *Pipistrelle* species to interact with the NBCRMs when roosting underneath roof tiles.

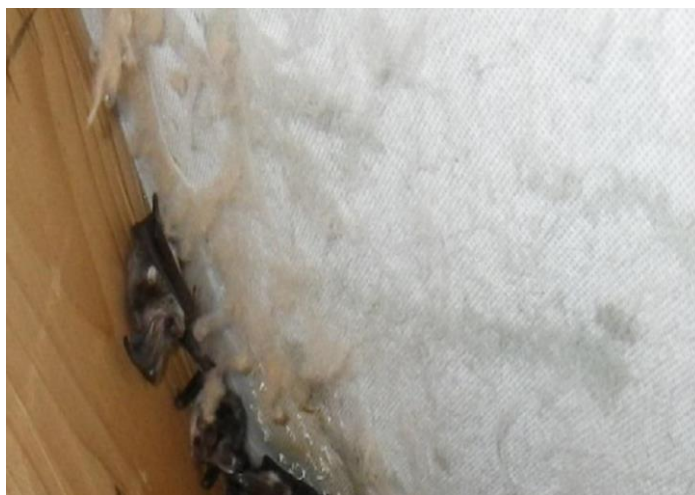
**Figure 14.** ‘Fluffing’ of a BRM surface four months after being fitted in a bat roost (Sample B)

It is informative to consider these results in the light of the field study data obtained for the samples exposed to live bats at the Isle of Wight bat hospital. Firstly, it is evident from Figure 14 that the mode of damage, i.e. dislodgement of continuous filaments and ‘fluffing’ of the fabric surface evident in the bat aviary-retrieved samples is replicated in the pilling-box test method reported herein.
